## Failures due to copper sulphide in transformer insulation

by M Dahlund et al, CIGRÉ SCA2 committee

In recent years a number of failures of transformers and reactors have occurred due to copper sulphide formation in the windings.

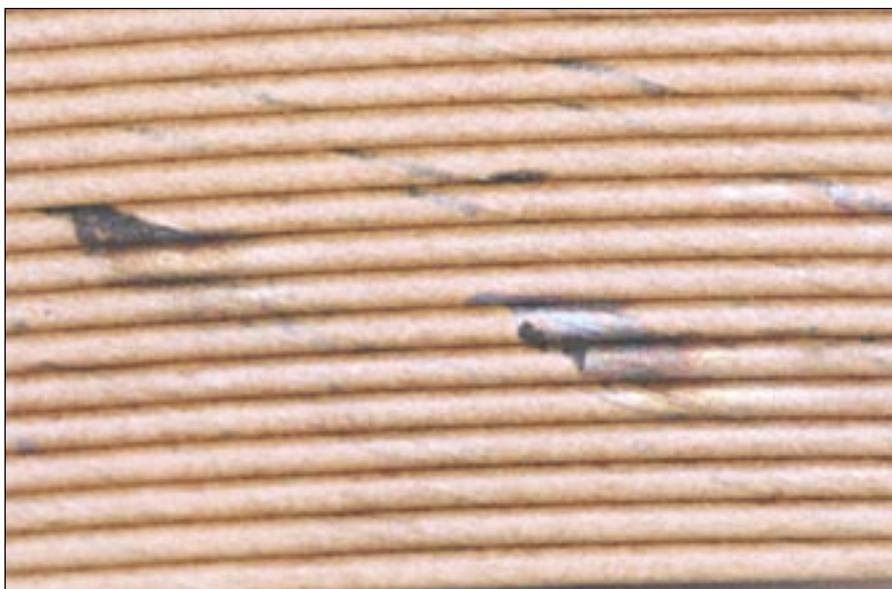
Fig. 1: Example of copper sulphide growing through several layers of covering paper.

interaction. Sometimes increased corrosivity is seen in the traditional meaning of the word, i.e. with blackening of copper and silver surfaces. This may be a serious problem in some cases. However, the larger problem seems to be the precipitation of semiconductive copper sulphide in or on the solid insulation, something which causes significant deterioration to its dielectric properties. In some cases growth of copper sulphide is found starting at the innermost layer of covering paper on the conductors, eventually growing through several layers. In other cases copper sulphide is found deposited on the outside of the conductors' paper wrapping, or on spacers. Examples are shown in Figs. 1 - 3.

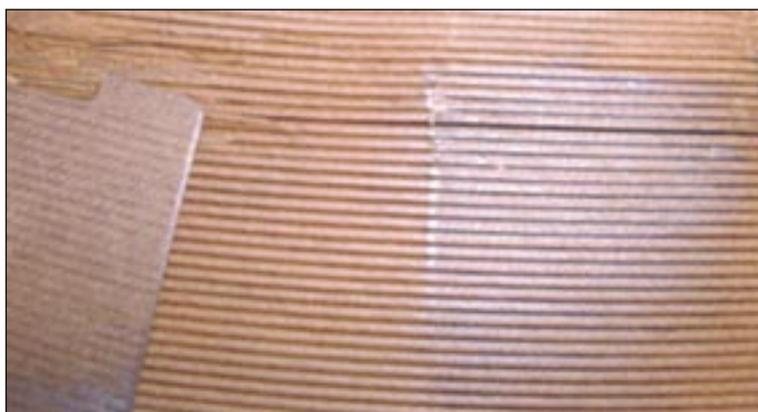
Fig.3: Example of copper sulphide deposited on spacer and under spacer. Similar deposits may also sometimes be seen on the outside of conductors in the area between the spacers.
